Corrosion

OFFICIAL PUBLICATION
NATIONAL ASSOCIATION OF CORROSION ENGINEERS

December, 1945

Electrolysis Surveys on Underground Cables, By L. J. Gorman.....	163
Marine Corrosion Testing Station at Kure Beach, N. C.....	178
The Behavior of Zinc-Iron Couples in Carbonate Soil, By T. H. Gilbert and Guy Corfield.....	187
Control of Pipe-Line Corrosion—A Manual, Part I, By O. C. Mudd.....	192
Corrosion Protection by Phosphatization, By Michael A. Streicher.....	219
Notes on Use of Copper-Nickel Alloy in HF Alkylation Processes, By B. B. Morton.....	228
N.A.C.E. Organization Chart.....	18
Corrosion Abstracts.....	21
Geographical Roster of N.A.C.E. Membership.....	38
Index to Advertisers.....	46

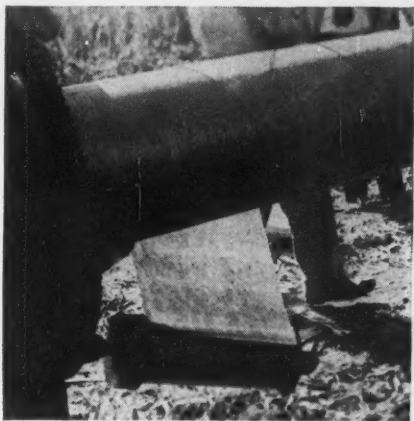
● Above: Section of underground pipe, covered with Fiberglas Mat, after five years of service. Volatile oils were still preserved in the coating, indicating many more years of service are available.

● Below: Fiberglas Underground Pipe Wrap is easy to handle. The flexibility and strength of Fiberglas Mat permit easy application with conventional wrapping equipment.

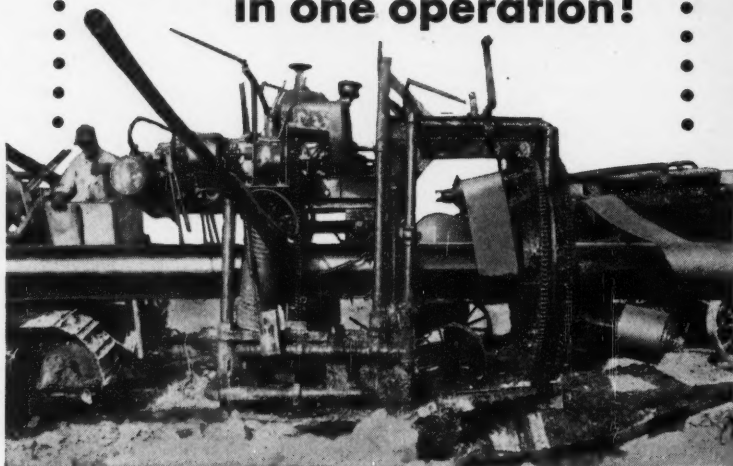
This new J-M machine
DOUBLE COATS
and DOUBLE WRAPS
in one operation!

THIS ingenious J-M machine alternately applies *two* layers of Johns-Manville Asbestos Felts and *two* coats of enamel to give protection against severe corrosive conditions.

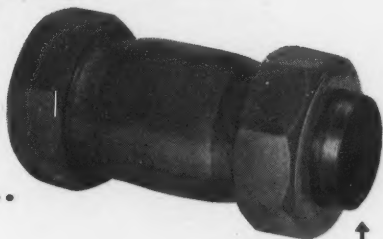
STOP CURRENT

at this Insulating Coupling →

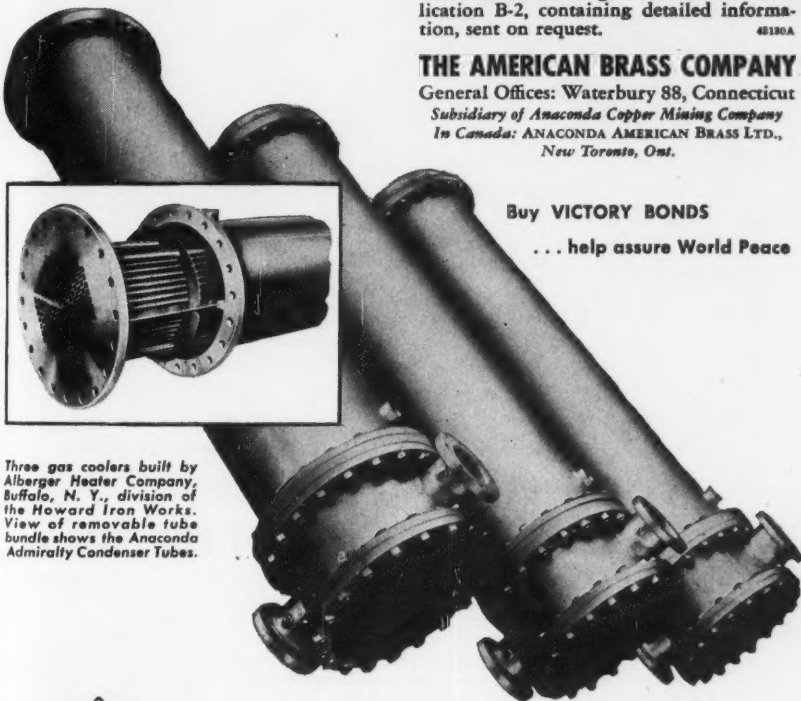
Three gas coolers built by Alberger Heater Company, Buffalo, N. Y., division of the Howard Iron Works. View of removable tube bundle shows the Anaconda Admiralty Condenser Tubes.

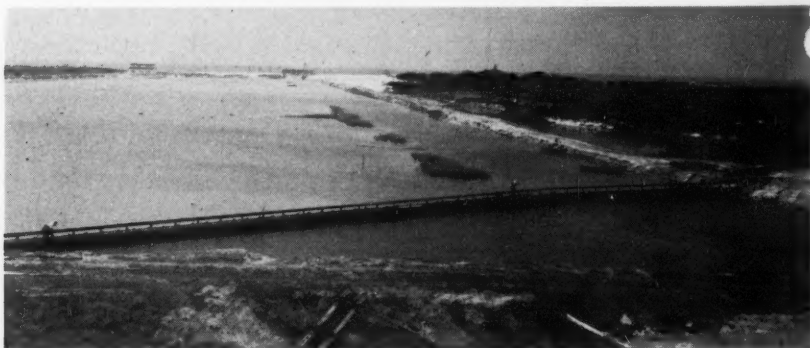
Figure 1—Sea water pond at chemical plant, used for study of samples under marine corrosive conditions.

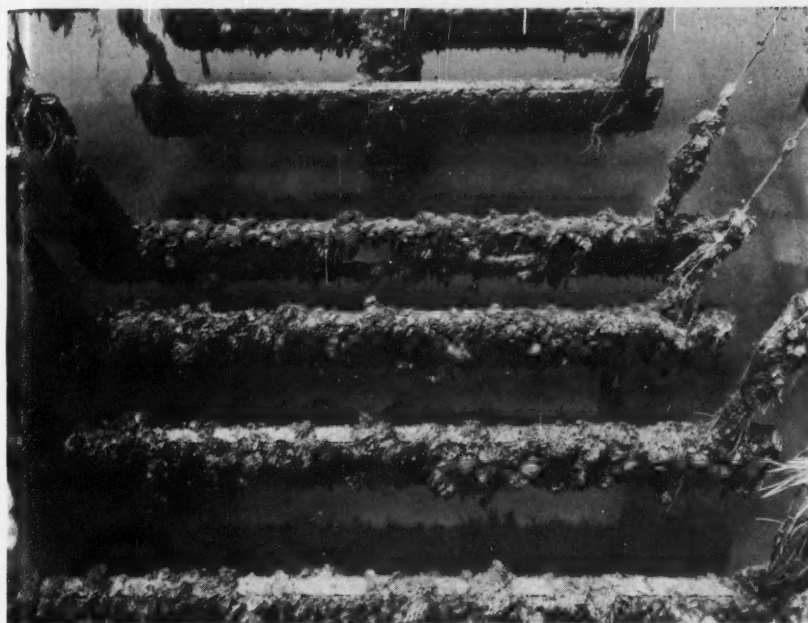
Figure 2 (above)—Racks exposed when pond is drained for examination of samples.
Figure 3 (below)—Oyster "crop" on intermittently immersed racks of specimens.

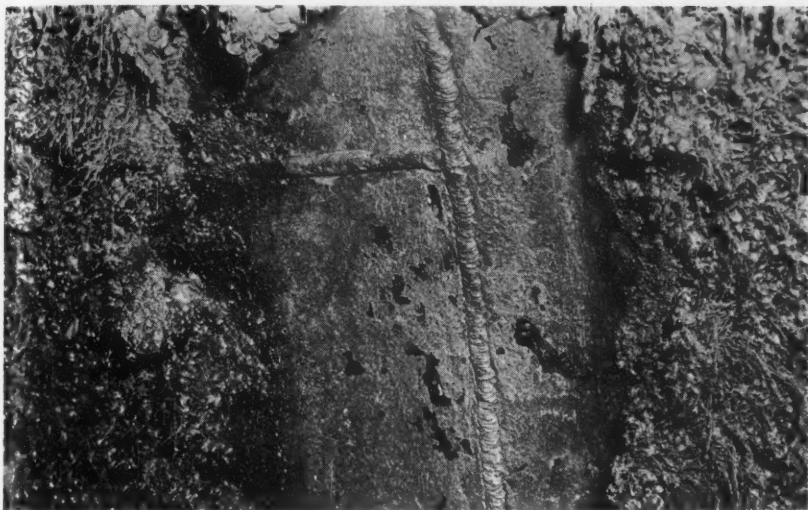
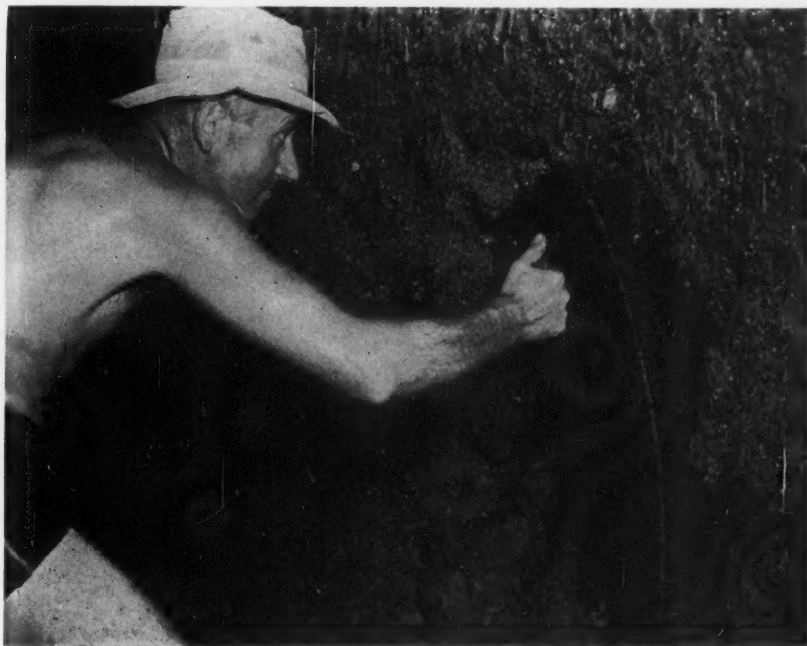
Figure 5 (above)—Typical section of steel weld after 6 years' service. Figure 6 (below)—Close-up of marine growth, showing thickness of matted material.

In this testing program it is possible to set up some tests which duplicate actual service. Figures 5, 6 and 7 show results of tests on welded steel pipe and Figure 8 shows tests on steel piling where

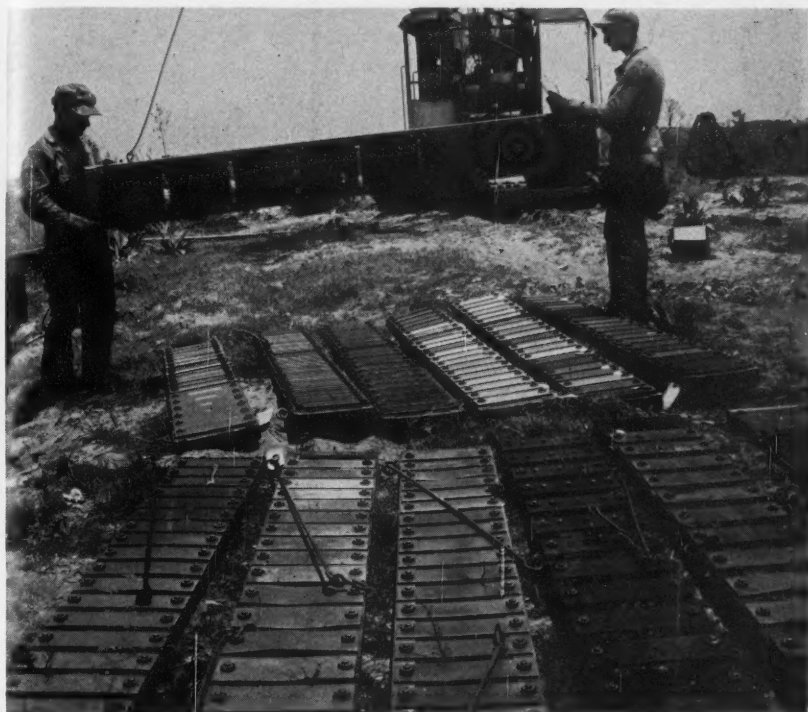
Figure 9 (above)—Racks ready for test, showing method of handling and supporting them. Figure 10 (below)—Racks exposed by draining water from intake pond.

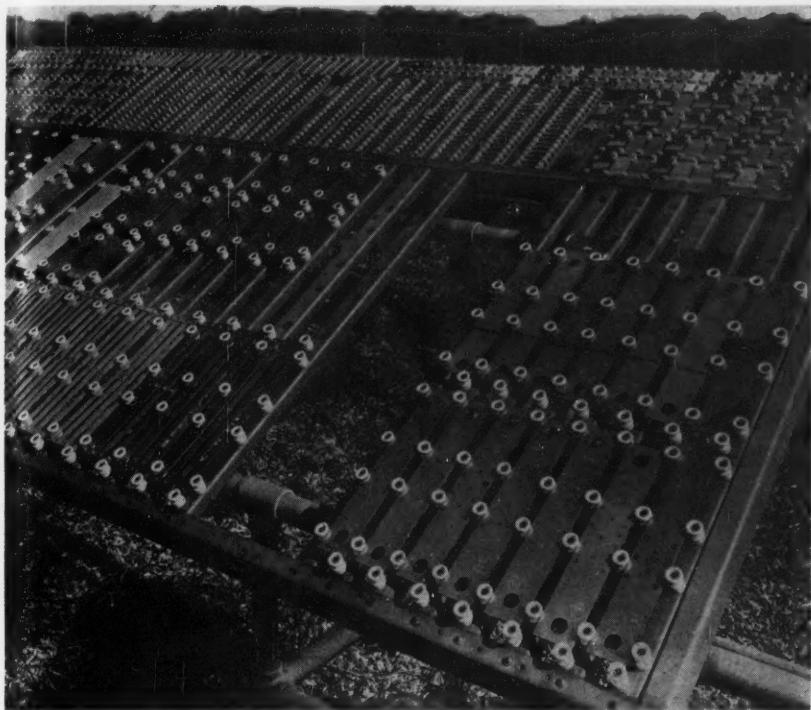
Figure 13 (above)—Variety of types of atmospheric test specimens, showing method of supporting. Figure 14 (below)—General view of atmospheric test racks and specimens.

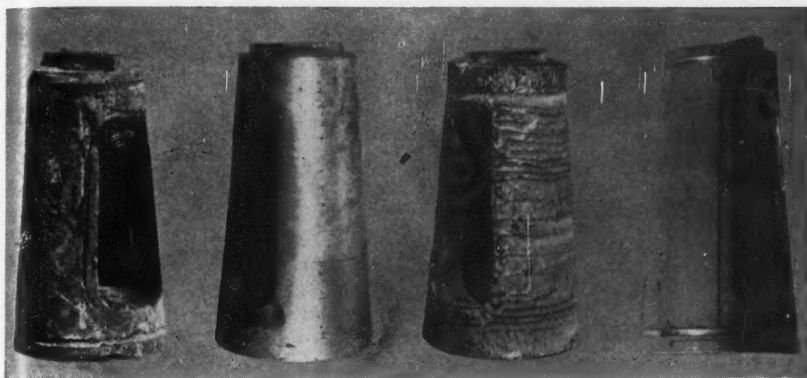
Figure 1—Four stages in the repair of the steel plug of a valve used in HF alkylation plants. At the left is a plug as pulled from service and requiring reconditioning. Adjacent is a similar plug, machined undersize for overlay of new metal. The third plug shows the manner in which the turned plug is overlaid with copper-nickel alloy, while the plug at the right has been finished, machined, ground and lapped, with lubrication grooves restored.

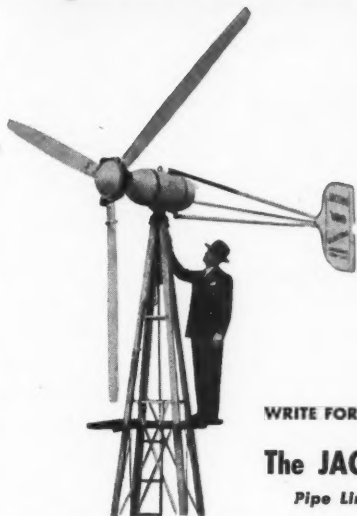
The New 1945 model *Jacobs Wind Electric* Pipe Line protection plant represents 10 years of development and proven dependability on pipe lines throughout America. Hundreds in service. Maximum output in light winds, because of its larger propeller, extremely low annual maintenance cost, no operating or fuel expense.
